Kenya, Tanzania, Mozambique and Madagascar

Antony Ndubi¹, Robinson Mugo¹, Lawrence Okello¹, Edward Ouko¹, Vincent Mtaroni¹, Hussein Farah¹, Flores Africa²
 1. Regional Centre for Mapping of Resources for Development, 2. The SERVIR Coordination Office, NASA Marshall Space Flight Centre, Huntsville, Alabama, USA.

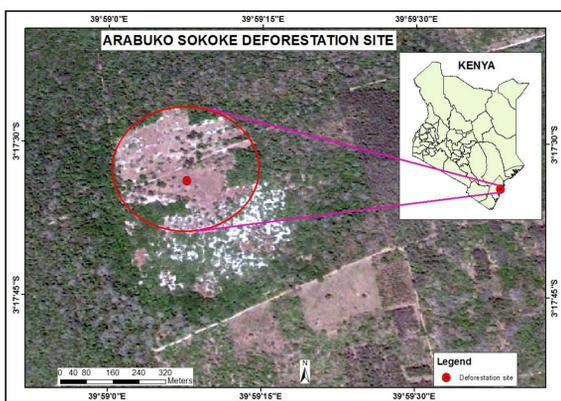
Fig. 6: Degraded site in Arabuko Sokoke Forest, Kenya (Image credit: Digital Globe)

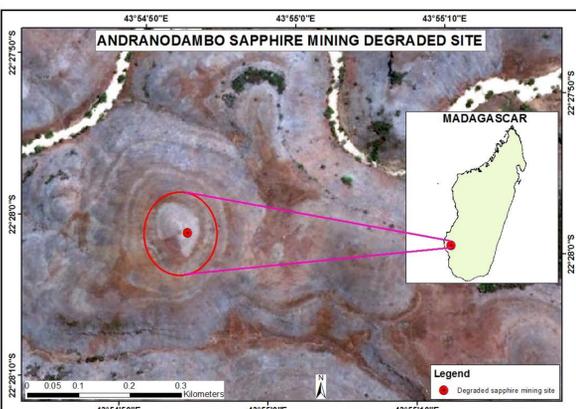
Fig. 7: Sapphire mining degraded site in Madagascar (Image credit: Digital Globe)

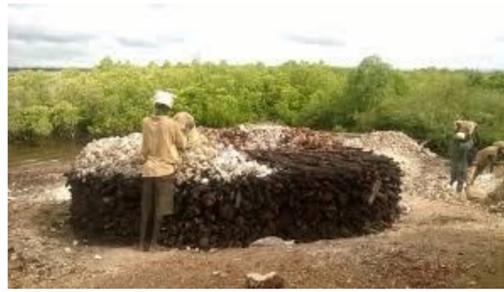
Fig. 1: Degradation of mangroves in Lamu, Kenya (Photo credit: commissionoceanindien.org)

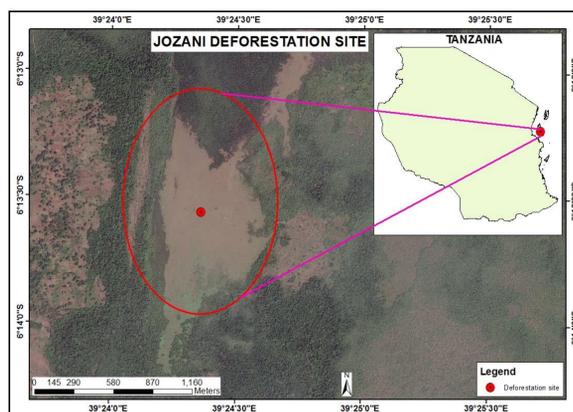
Fig. 5: Degraded site in Jozani Forest, Tanzania (Image credit: Digital Globe)

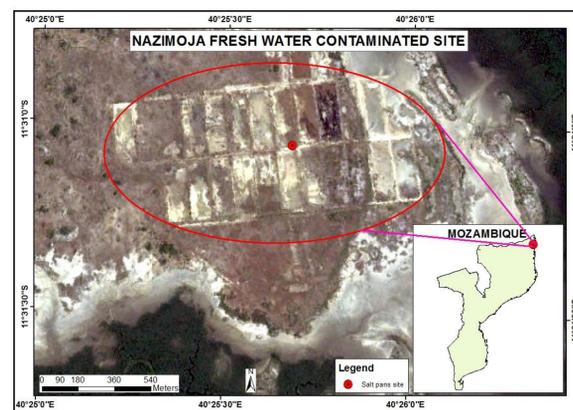
Fig. 8: Fresh water table salinized site in Nazimoja, Mozambique (Image credit: CNES/Astrium)

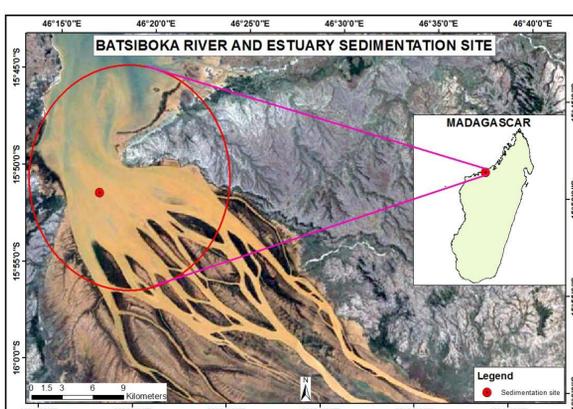
Fig. 9: Sedimented site in Batsiboka River Estuary, Madagascar (Image credit: CNES/Astrium)

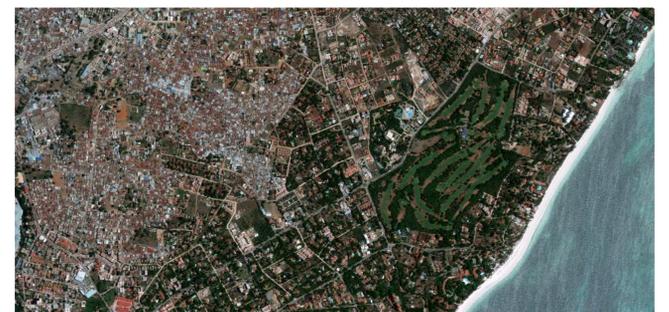
Fig. 3: GeoEye1 High Resolution Satellite Image (Image credit: Digital Globe)

- ▶ GeoEye-1 with 4 light channel bands of 0.5 meter spatial resolution.
- ▶ WorldView 2 with 8 light channel bands of 0.5 meter spatial resolution.

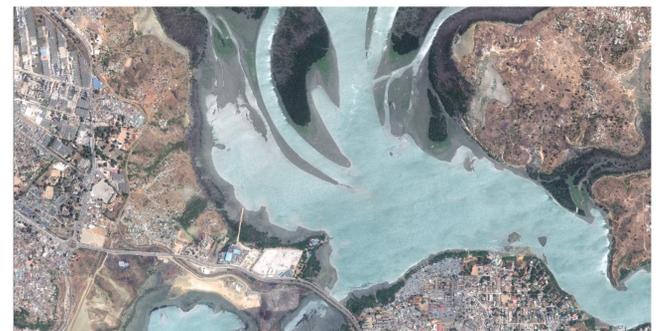
Fig. 4: WorldView2 High Resolution Satellite Image (Image credit: Digital Globe)
